# Access Compliance Report Public Rights-of-Way (Curb Ramps)

| Main Street: WINTHROPE_ST | | Cross Street: ERVIN_LN | | Location: | SW |
| ADA ID: RPAT211026130836 | Ramp Type: Type 4 - Parallel | Initial Pass/Fail: Fail | Overall Compliance: No | Severity Score: | 16 |

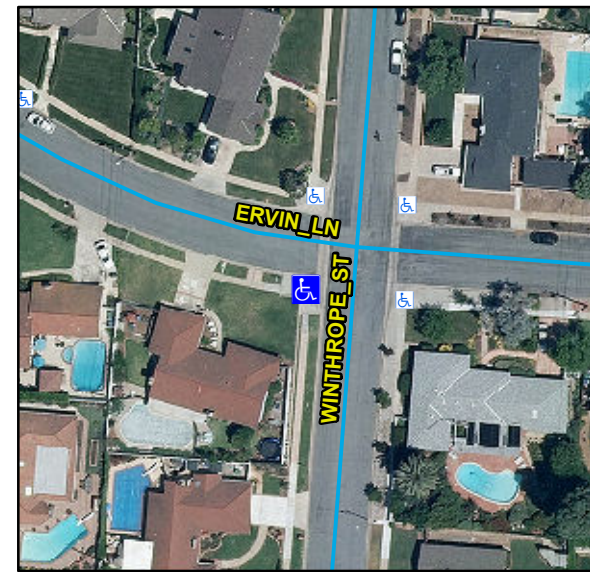
| Compliance | Description | Data | Compliance | Description | Data |
|---|---|---|---|---|---|
| Yes | Ramp Run Slope LT (%) | 2.9 | No | Ramp Run Slope RT (%) | 11.6 |
| No | Ramp Cross Slope LT (%) | 2.4 | Yes | Ramp Cross Slope RT (%) | 1.3 |

Possible Solutions:

**Remove & Replace Curb Ramp With Two New Directional Ramps or Equivalent.**

**R204.3, R304.5.3, R304.3.2, STD 1115**

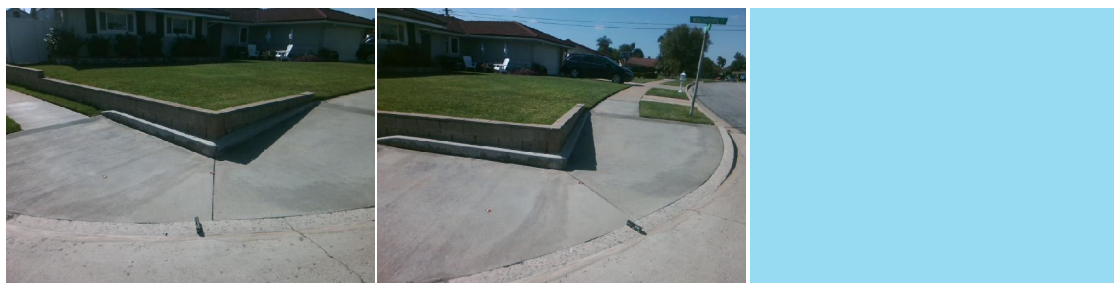
| Compliance | Description | Data | Compliance | Description | Data |
|---|---|---|---|---|---|
| N/A | Ramp Length LT (in) | 130 | N/A | Ramp Length RT (in) | 130 |
| Yes | Ramp Width LT (in) | 100 | Yes | Ramp Width RT (in) | 110 |
