# Access Compliance Report Public Rights-of-Way (Curb Ramps)

Main Street: ERVIN\_LN Cross Street: WINTHROPE\_ST Location: NW

ADA ID: RPAT211026131214 Ramp Type: Type 1 - Perpendicular Diagonal Initial Pass/Fail: Pass Overall Compliance: No Severity Score: 26

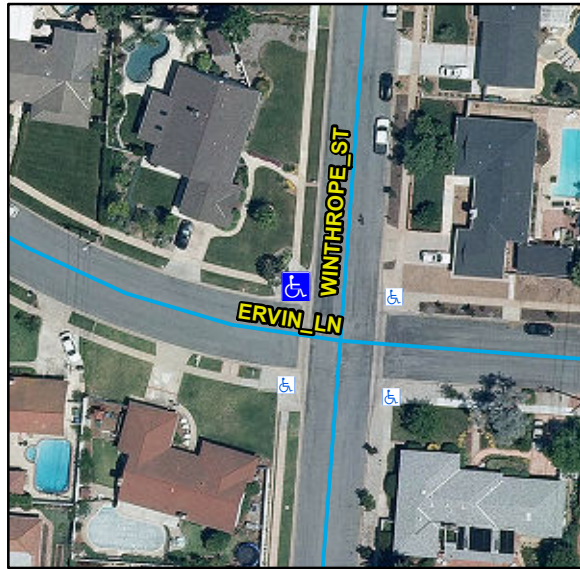
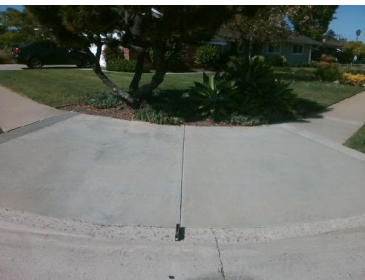
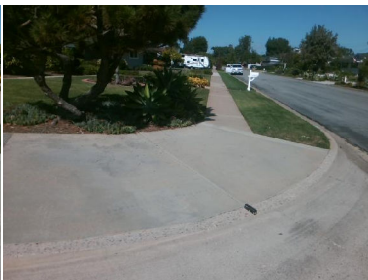
| Compliance | Description | Data | Compliance | Description | Data |
|---|---|---|---|---|---|
| No | Ramp Cross Slope (%) | 2.3 | N/A | Flare Traversable LT | No |
| No | Landing Width (in) | N/A | N/A | Flare Slope RT (%) | 3.5 |
| No | Landing Run Slope (%) | N/A | N/A | Flare Traversable RT | No |
| No | Landing Cross Slope (%) | N/A | No | DWS Provided | No |
| No | Gutter Run Slope (%) | 5.7 | | Road Cross Slope (%) | 4.8 |

Remove & Replace Curb Ramp With Two New Directional Ramps or Equivalent. Remove & Replace Gutter.
