# Access Compliance Report Public Rights-of-Way (Curb Ramps)

Main Street: HEWES\_AVE Cross Street: ERVIN\_LN Location: NE

ADA ID: RPAT211026132106 Ramp Type: Type 4 - Parallel Initial Pass/Fail: Fail Overall Compliance: No Severity Score: 4

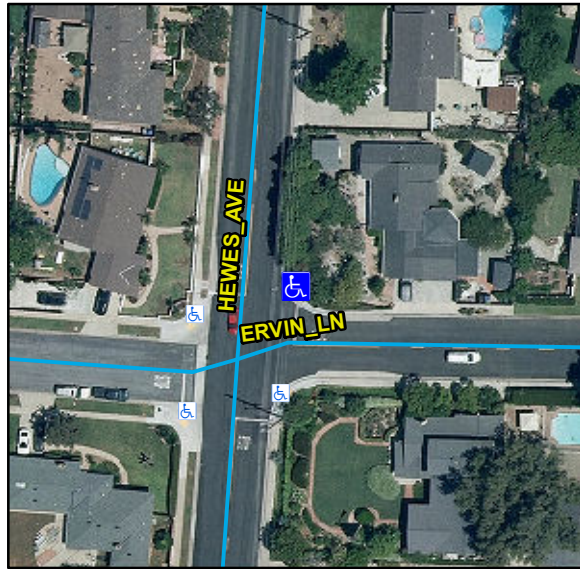
| Compliance | Description | Data | Compliance | Description | Data |
|---|---|---|---|---|---|
| No | Ramp Width LT (in) | 42 | No | Ramp Width RT (in) | 37 |

**Remove & Replace Curb Ramp With Two New Directional Ramps or Equivalent.**

**R304.5.1, STD 1115**
