# Access Compliance Report Public Rights-of-Way (Curb Ramps)

Main Street: ERVIN\_LN Cross Street: HEWES\_AVE Location: SE

ADA ID: RPAT211026132330 Ramp Type: Type 4 - Parallel Initial Pass/Fail: Fail Overall Compliance: No Severity Score: 4

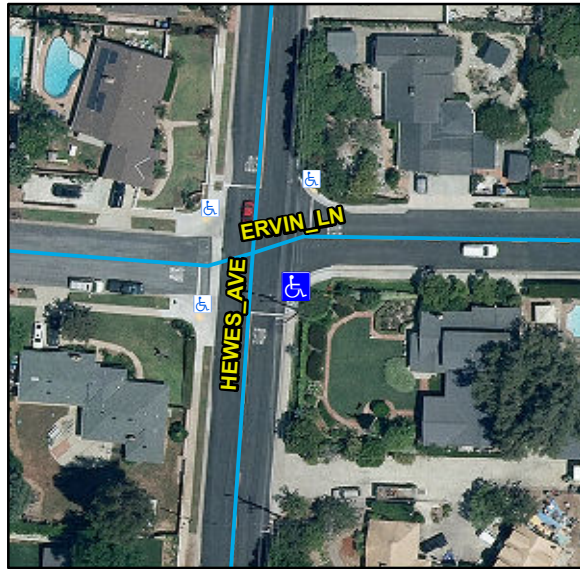
| Compliance | Description | Data | Compliance | Description | Data |
|---|---|---|---|---|---|
| No | Ramp Width LT (in) | 45 | No | Ramp Width RT (in) | 47 |

**Remove & Replace Curb Ramp With Two New Directional Ramps or Equivalent.**

**R304.5.1, STD 1115**
