# Access Compliance Report Public Rights-of-Way (Curb Ramps)

Main Street: LASSEN\_DR Cross Street: ESPLANADE\_AVE Location: NW

ADA ID: RPAT211026140300 Ramp Type: Type 1 - Perpendicular Diagonal Initial Pass/Fail: Fail Overall Compliance: No Severity Score: 15

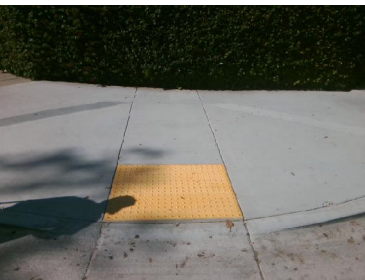
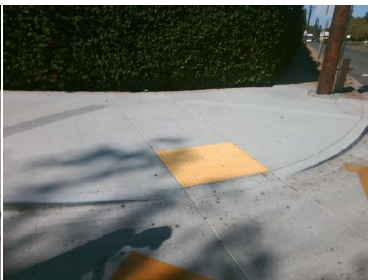
| Compliance | Description | Data | Compliance | Description | Data |
|---|---|---|---|---|---|
| No | Ramp Run Slope (%) | 8.4 | N/A | Flare Slope LT (%) | N/A |
| N/A | Ramp Inside Crosswalk 1 | N/A | Yes | Ramp Inside Crosswalk 2 | Yes |
| N/A | Gutter Ponding | N/A | No | Curb Slope | 9.3 |

**Remove & Replace Curb Ramp With Two New Directional Ramps or Equivalent.**

**R304.2.2, STD 1115**
