# Access Compliance Report Public Rights-of-Way (Curb Ramps)

Main Street: CRANBROOK\_DR Cross Street: ESPLANADE\_AVE Location: NW

ADA ID: RPAT211026143737 Ramp Type: Type 6 - Directional 1 Initial Pass/Fail: Pass Overall Compliance: No Severity Score: 4

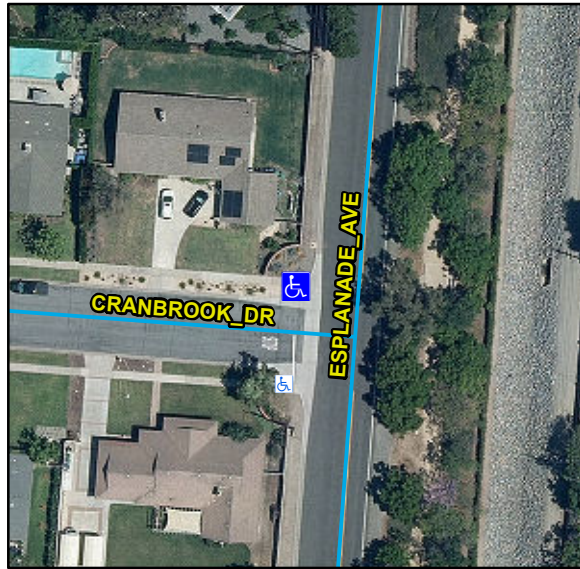
| Compliance | Description | Data | Compliance | Description | Data |
|---|---|---|---|---|---|
| No | Landing Length (in) | 43 | Yes | DWS Length (in) | 36 |
| Yes | Gutter Ponding | No | No | Curb Slope | 8.8 |

Remove & Replace Entire Ramp.

R304.2.2, R304.2.1, STD 1115

Total Cost: \$ 3080
