# Access Compliance Report Public Rights-of-Way (Curb Ramps)

Main Street: CRANBROOK\_DR Cross Street: ESPLANADE\_AVE Location: SW

ADA ID: RPAT211026144152 Ramp Type: Type 6 - Directional 1 Initial Pass/Fail: Fail Overall Compliance: No Severity Score: 15

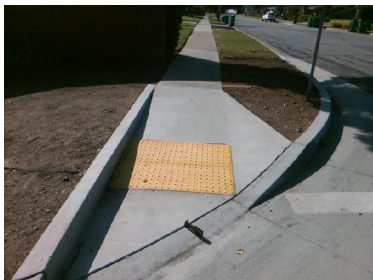
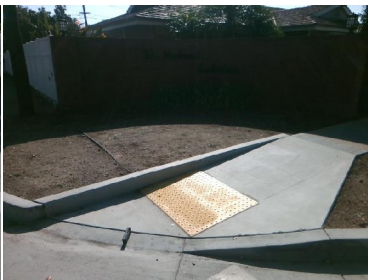
| Compliance | Description | Data | Compliance | Description | Data |
|---|---|---|---|---|---|
| No | Ramp Run Slope (%) | 10 | N/A | Flare Slope LT (%) | N/A |

Remove & Replace Entire Ramp.
