# Access Compliance Report Public Rights-of-Way (Curb Ramps)

Main Street: DALL\_LN Cross Street: JOSHUA\_LN Location: SW

ADA ID: RPAT211026145428 Ramp Type: Type 1 - Perpendicular Diagonal Initial Pass/Fail: Fail Overall Compliance: No Severity Score: 16

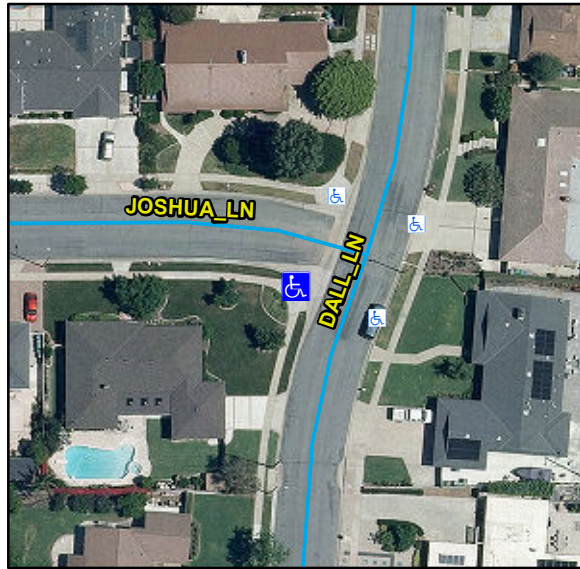
| Compliance | Description | Data | Compliance | Description | Data |
|---|---|---|---|---|---|
| No | Ramp Run Slope (%) | 8.4 | N/A | Flare Slope LT (%) | N/A |

Remove & Replace Curb Ramp With Two New Directional Ramps or Equivalent.
