# Access Compliance Report Public Rights-of-Way (Curb Ramps)

Main Street: IRVINE\_BLVD Cross Street: RED\_HILL\_AVE Location: NE

ADA ID: RPAT211027085403 Ramp Type: Type 1 - Perpendicular Diagonal Initial Pass/Fail: Fail Overall Compliance: No Severity Score: 2

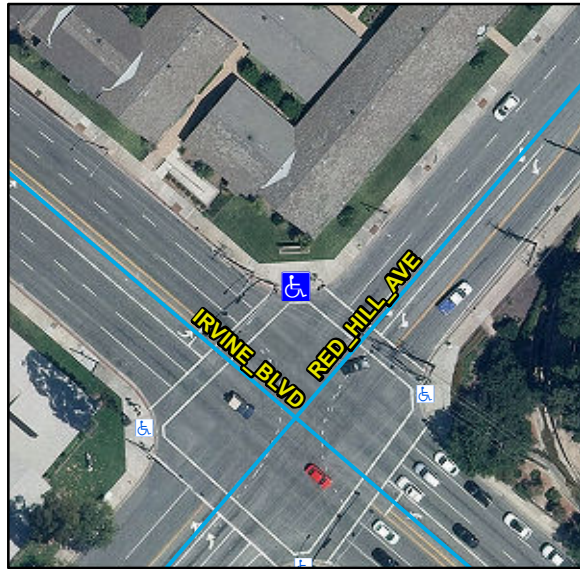
| Compliance | Description | Data | Compliance | Description | Data |
|---|---|---|---|---|---|
| No | Ramp Cross Slope (%) | 3.9 | N/A | Flare Traversable LT | N/A |

Remove & Replace Curb Ramp With Two New Directional Ramps or Equivalent.

R204.3, R304.5.3, STD 1115
