# Access Compliance Report Public Rights-of-Way (Curb Ramps)

Main Street: RED\_HILL\_AVE Cross Street: IRVINE\_BLV Location: SE

ADA ID: RPAT211027090156 Ramp Type: Type 1 - Perpendicular Diagonal Initial Pass/Fail: Fail Overall Compliance: No Severity Score: 15

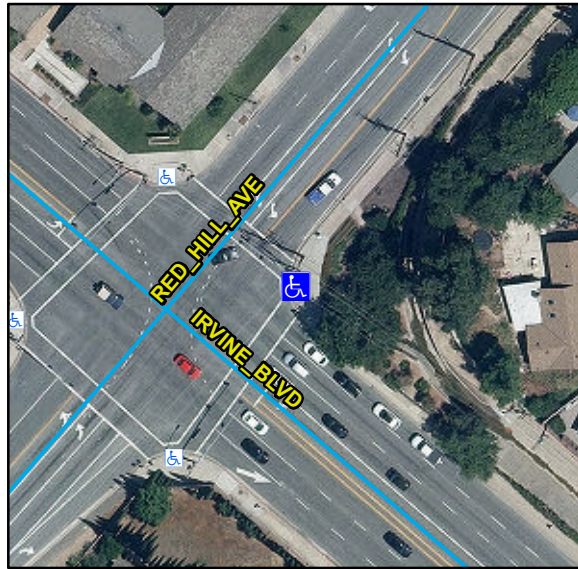
| Compliance | Description | Data | Compliance | Description | Data |
|---|---|---|---|---|---|
| No | Ramp Run Slope (%) | 8.6 | N/A | Flare Slope LT (%) | N/A |

**Remove & Replace Curb Ramp With Two New Directional Ramps or Equivalent.**

**R304.2.2, R204.3, STD 1115**
