# Access Compliance Report Public Rights-of-Way (Curb Ramps)

Main Street: RED\_HILL\_AVE Cross Street: IRVINE\_BLV Location: W

ADA ID: RPAT211027091610 Ramp Type: Type 1 - Perpendicular Diagonal Initial Pass/Fail: Pass Overall Compliance: No Severity Score: 16

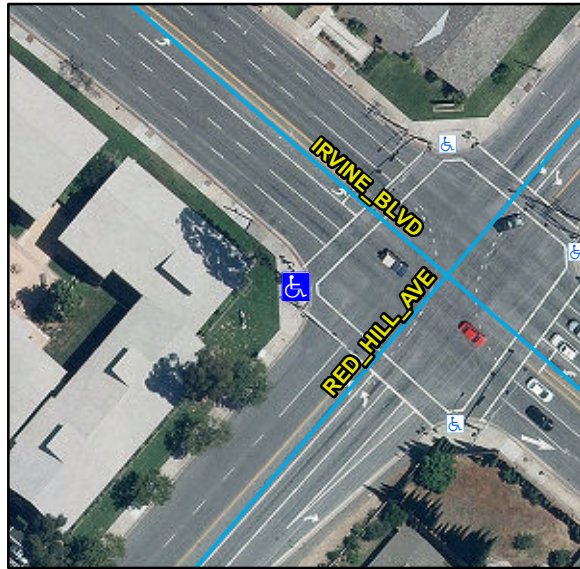
| Compliance | Description | Data | Compliance | Description | Data |
|---|---|---|---|---|---|
| No | Ramp Cross Slope (%) | 3.9 | N/A | Flare Traversable LT | No |
| No | Landing Cross Slope (%) | 3.8 | No | DWS Provided | No |
| No | Gutter Run Slope (%) | 10.1 | | Road Cross Slope (%) | 4.7 |
| No | Gutter Cross Slope (%) | 3.4 | | | |

Remove & Replace Curb Ramp With Two New Directional Ramps or Equivalent. Remove & Replace Gutter.

R304.5.3, R305, R304.5.4, STD 1115
