# Access Compliance Report Public Rights-of-Way (Curb Ramps)

| Main Street: N/A | | Cross Street: IRVINE_BLV | | Location: | SW |
| ADA ID: RPAT211027105841 | Ramp Type:Type 1 - Perpendicular | Initial Pass/Fail: Fail | Overall Compliance: No | Severity Score: | 15 |

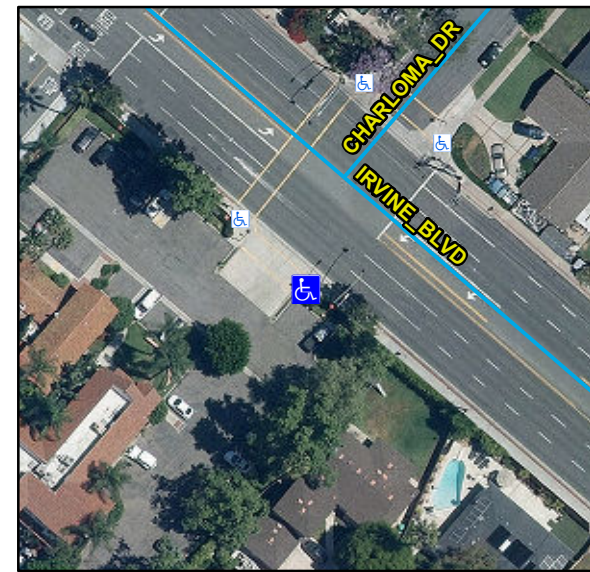
| Compliance | Description | Data | Compliance | Description | Data |
|---|---|---|---|---|---|
| No | Ramp Run Slope (%) | 8.9 | N/A | Flare Slope LT (%) | N/A |
| N/A | Gutter Ponding | N/A | No | Curb Slope | 7.3 |

Remove & Replace Entire Ramp.

R304.2.2, STD 1115
