# Access Compliance Report Public Rights-of-Way (Curb Ramps)

Main Street: IRVINE\_BLVD Cross Street: N/A Location: W

ADA ID: RPAT211027110327 Ramp Type: Type 1 - Perpendicular Diagonal Initial Pass/Fail: Fail Overall Compliance: No Severity Score: 16

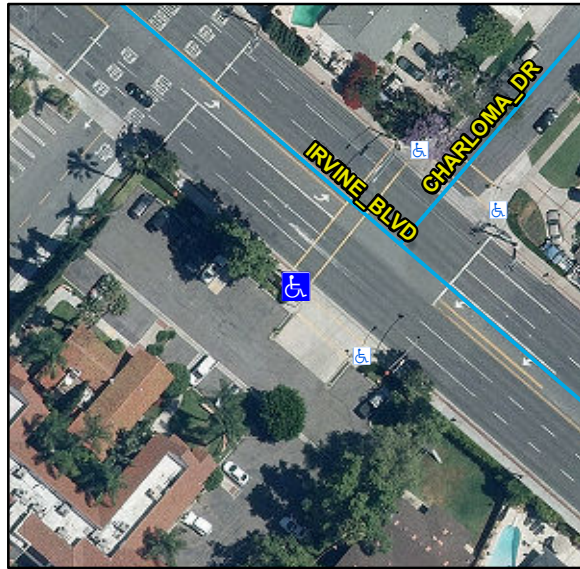
| Compliance | Description | Data | Compliance | Description | Data |
|---|---|---|---|---|---|
| No | Ramp Run Slope (%) | 11.9 | N/A | Flare Slope LT (%) | N/A |
| No | Ramp Cross Slope (%) | 3.1 | N/A | Flare Traversable LT | N/A |

Remove & Replace Curb Ramp With Two New Directional Ramps or Equivalent.

R304.2.2, R304.5.3, STD 1115
