# Access Compliance Report Public Rights-of-Way (Curb Ramps)

| Main Street: CHARLOMA_DR | | Cross Street: IRVINE_BLVD | | Location: | SE |
| ADA ID: RPAT211027111742 | Ramp Type: Type 3 - Combination 1 | Initial Pass/Fail: Fail | Overall Compliance: No | Severity Score: | 16 |

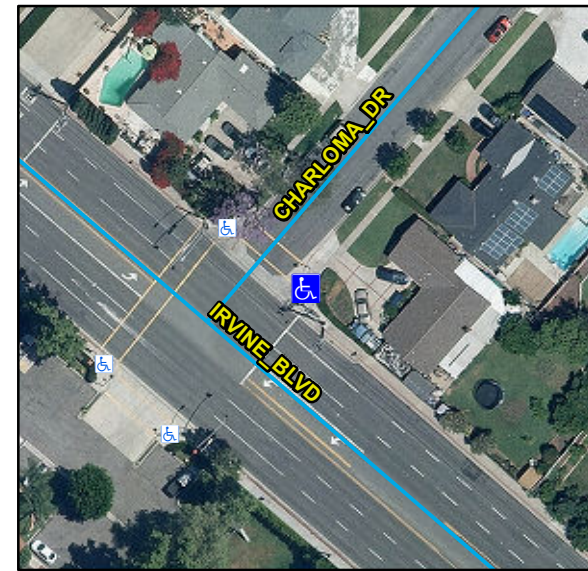
| Compliance | Description | Data | Compliance | Description | Data |
|---|---|---|---|---|---|
| No | Ramp Run Slope LT (%) | 11.4 | Yes | Ramp Run Slope RT (%) | 2.5 |
| No | Ramp Cross Slope (%) | 3.5 | N/A | Flare Traversable LT | N/A |
| N/A | Gutter Ponding | N/A | No | Curb Slope | 10.3 |

Possible Solutions:

Remove & Replace Entire Ramp.

R304.2.2, R304.5.3, R304.3.2, STD 1115
