# Access Compliance Report Public Rights-of-Way (Curb Ramps)

Main Street: VERA\_ST Cross Street: WARREN\_AVE Location: E

ADA ID: RPAT211027113849 Ramp Type: Type 6 - Directional 1 Initial Pass/Fail: Fail Overall Compliance: No Severity Score: 19

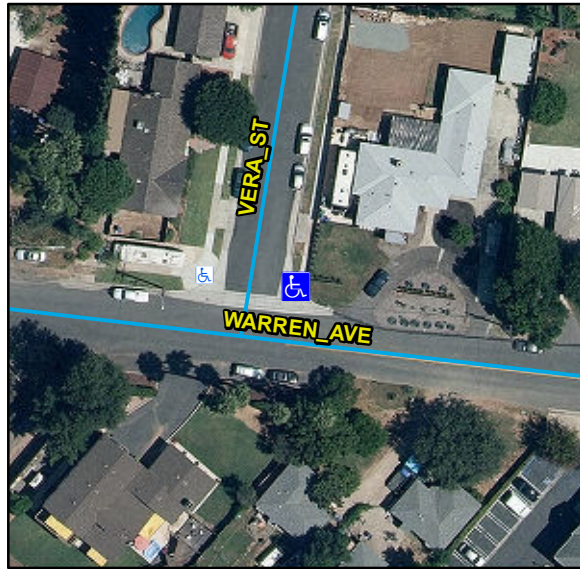
| Compliance | Description | Data | Compliance | Description | Data |
|---|---|---|---|---|---|
| No | Ramp Width (in) | 45 | | | N/A |
| No | Ramp Run Slope (%) | 8.4 | N/A | Flare Slope LT (%) | N/A |

Remove & Replace Entire Ramp.

R304.5.1, R304.2.2, STD 1115
