# Access Compliance Report Public Rights-of-Way (Curb Ramps)

| Main Street: VERA_ST | | Cross Street: WARREN_AVE | | Location: | NW |
| ADA ID: RPAT211027114109 | Ramp Type:Type 1 - Perpendicular | Initial Pass/Fail: Fail | Overall Compliance: No | Severity Score: | 16 |

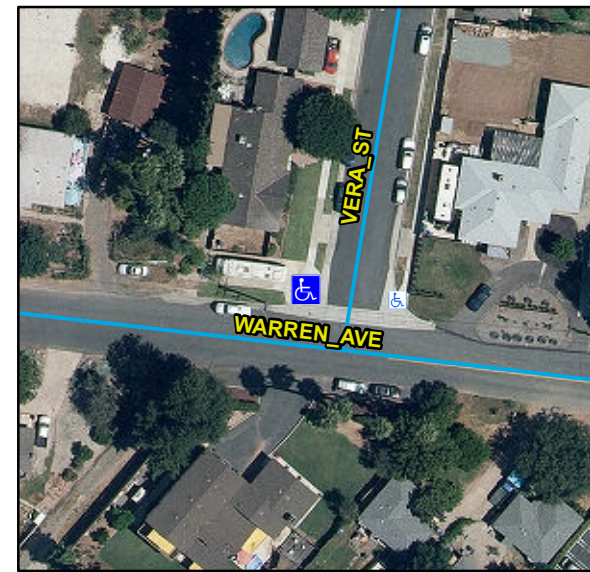
| Compliance | Description | Data | Compliance | Description | Data |
|---|---|---|---|---|---|
| No | Ramp Run Slope (%) | 9.5 | N/A | Flare Slope LT (%) | N/A |
| No | Ramp Cross Slope (%) | 4.3 | N/A | Flare Traversable LT | N/A |

Possible Solutions:

Remove & Replace Entire Ramp.

R304.2.2, R304.5.3, STD 1115
