# Access Compliance Report Public Rights-of-Way (Curb Ramps)

Main Street: WARREN\_AVE Cross Street: NEWPORT\_AVE Location: NW

ADA ID: RPAT211027114716 Ramp Type: Type 1 - Perpendicular Diagonal Initial Pass/Fail: Fail Overall Compliance: No Severity Score: 4

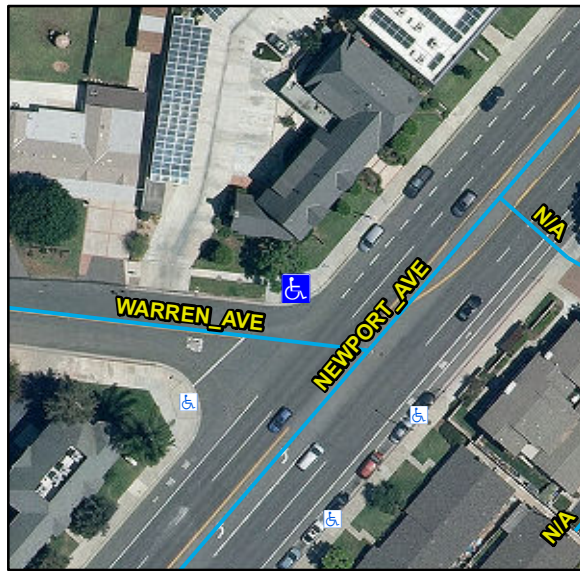
R304.2.2, R304.5.1, STD 1115

| Compliance | Description | Data | Compliance | Description | Data |
|---|---|---|---|---|---|
| No | Ramp Width (in) | 47 | | | N/A |

Remove & Replace Curb Ramp With Two New Directional Ramps or Equivalent.
