# Access Compliance Report Public Rights-of-Way (Curb Ramps)

Main Street: WINDSOR\_LN Cross Street: NEWPORT\_AVE Location: SE

ADA ID: RPAT211027115241 Ramp Type: Type 1 - Perpendicular Diagonal Initial Pass/Fail: Pass Overall Compliance: No Severity Score: 2

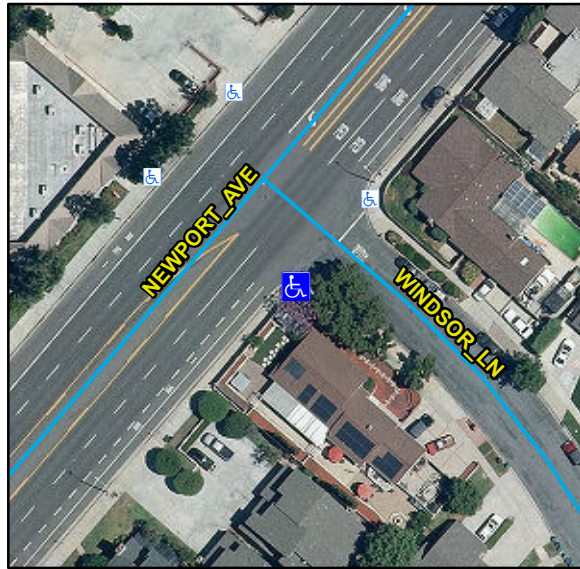
| Compliance | Description | Data | Compliance | Description | Data |
|---|---|---|---|---|---|
| No | Ramp Cross Slope (%) | 2.4 | N/A | Flare Traversable LT | No |
| Yes | Gutter Ponding | No | No | Curb Slope | 7.1 |

**Remove & Replace Curb Ramp With Two New Directional Ramps or Equivalent.**

**R304.2.2, R304.5.3, STD 1115**
