# Access Compliance Report Public Rights-of-Way (Curb Ramps)

Main Street: NEWPORT\_AVE Cross Street: WINDSOR\_LN Location: SE

ADA ID: RPAT211027115656 Ramp Type: Type 1 - Perpendicular Diagonal Initial Pass/Fail: Fail Overall Compliance: No Severity Score: 2

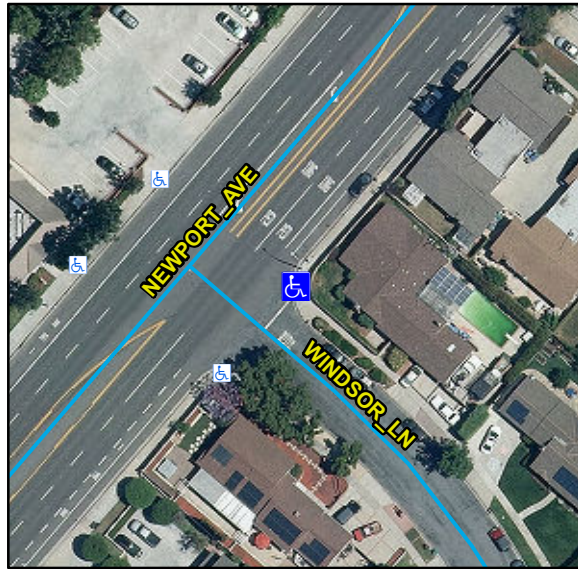
| Compliance | Description | Data | Compliance | Description | Data |
|---|---|---|---|---|---|
| No | Ramp Cross Slope (%) | 2.8 | N/A | Flare Traversable LT | N/A |

Remove & Replace Curb Ramp With Two New Directional Ramps or Equivalent.
