# Access Compliance Report Public Rights-of-Way (Curb Ramps)

Main Street: E\_BOND\_AVE Cross Street: N\_SWAN\_ST Location: NW

ADA ID: RPAT211027135322 Ramp Type: Type 1 - Perpendicular Diagonal Initial Pass/Fail: Pass Overall Compliance: No Severity Score: 0

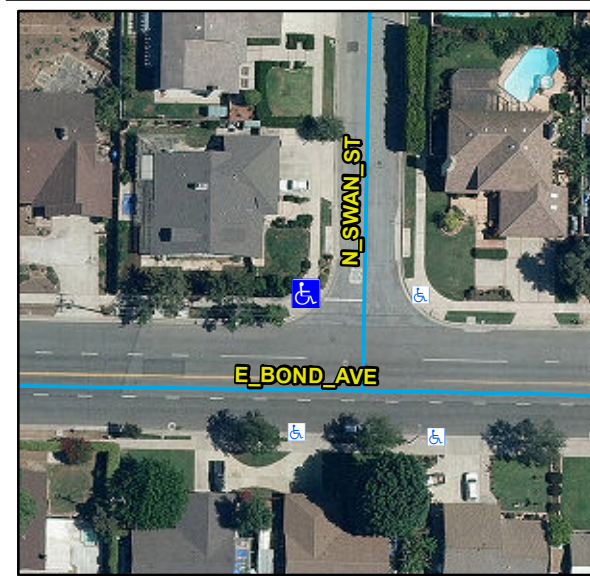
| Compliance | Description | Data | Compliance | Description | Data |
|---|---|---|---|---|---|
| No | Gutter Cross Slope (%) | 2.3 | | | |

Possible Solutions:  
**Remove & Replace Landing. Remove & Replace Gutter.**

OC Std/PROW:  
**R304.2.1, R304.5.3, STD 1115**
