# Access Compliance Report Public Rights-of-Way (Curb Ramps)

Main Street: N\_SWAN\_ST Cross Street: E\_BOND\_AVE Location: NE

ADA ID: RPAT211027135831 Ramp Type: Type 1 - Perpendicular Diagonal Initial Pass/Fail: Pass Overall Compliance: No Severity Score: 0

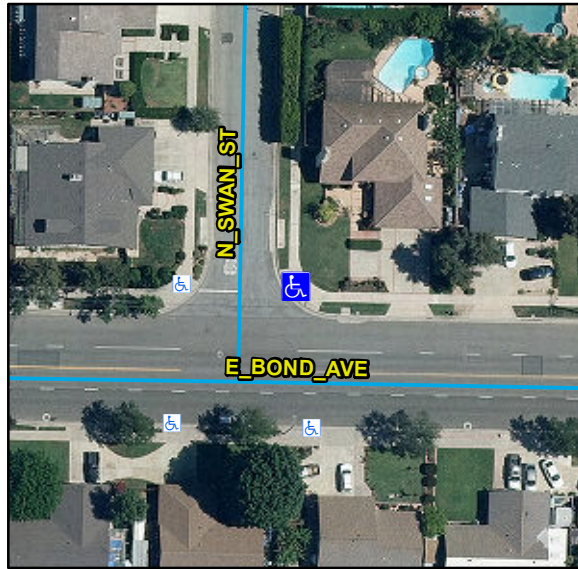
| Compliance | Description | Data | Compliance | Description | Data |
|---|---|---|---|---|---|
| No | Landing Run Slope (%) | 2.1 | N/A | Flare Traversable RT | No |

Remove & Replace Landing.

R304.2.2-Perp, R304.3.2-Para, STD 1115
