# Access Compliance Report Public Rights-of-Way (Curb Ramps)

Main Street: BOND\_AVE Cross Street: HEWES\_ST Location: SE

ADA ID: RPAT211027141207 Ramp Type: Type 4 - Parallel Initial Pass/Fail: Fail Overall Compliance: No Severity Score: 15

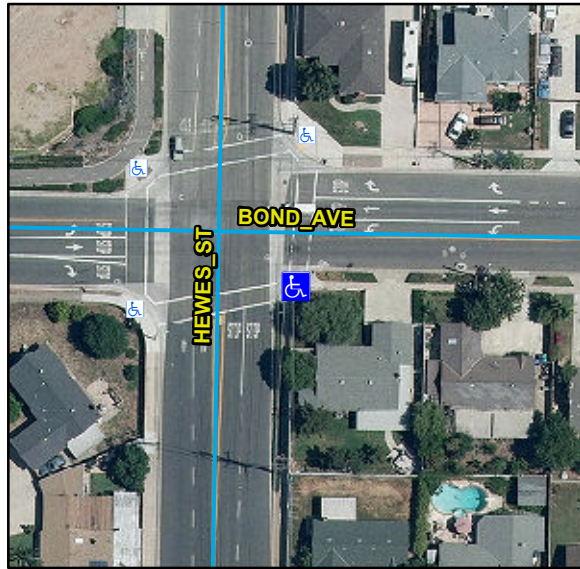
| Compliance | Description | Data | Compliance | Description | Data |
|---|---|---|---|---|---|
| No | Ramp Run Slope LT (%) | 8.6 | Yes | Ramp Run Slope RT (%) | 6.2 |

**Remove & Replace Curb Ramp With Two New Directional Ramps or Equivalent.**

**R304.3.2, STD 1115**
