# Access Compliance Report Public Rights-of-Way (Curb Ramps)

Main Street: HEWES\_ST Cross Street: BOND\_AVE Location: SW

ADA ID: RPAT211027141603 Ramp Type: Type 1 - Perpendicular Diagonal Initial Pass/Fail: Pass Overall Compliance: No Severity Score: 4

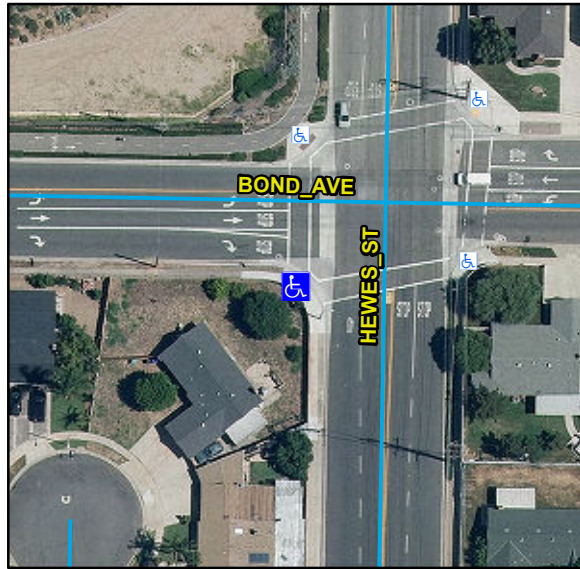
| Compliance | Description | Data | Compliance | Description | Data |
|---|---|---|---|---|---|
| Yes | Gutter Ponding | No | No | Curb Slope | 14.3 |
| No | Gutter Cross Slope (%) | 2.3 | | | |

Remove & Replace Curb Ramp With Two New Directional Ramps or Equivalent. Remove & Replace Gutter.
