Access Compliance Report Public Rights-of-Way (Curb Ramps)

Main Street: BOND_AVE **Cross Street: HEWES_ST** **Location: NW**

ADA ID: RPAT211027141950 **Ramp Type: Type 1 - Perpendicular Diagonal Initial Pass/Fail: Fail** **Overall Compliance: No** **Severity Score: 15**

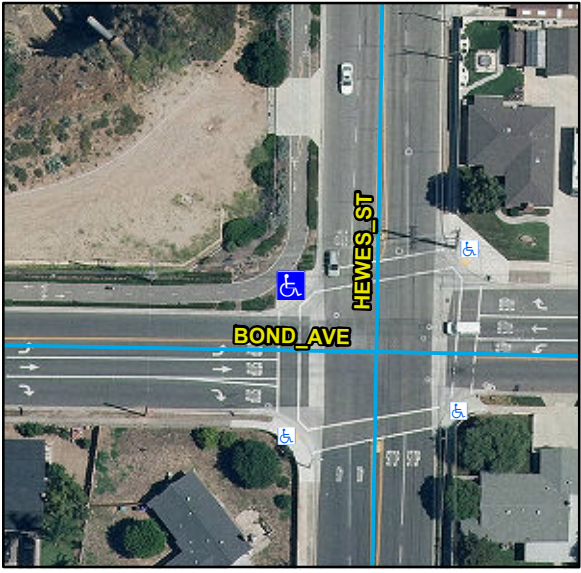
Compliance	Description	Data	Compliance	Description	Data
N/A	Ramp Length (in)	133	N/A	Flare Type LT	
Yes	Ramp Width (in)	120			N/A
No	Ramp Run Slope (%)	8.4	N/A	Flare Slope LT (%)	N/A
Yes	Ramp Cross Slope (%)	0.3	N/A	Flare Traversable LT	N/A
N/A	Landing Present	N/A	N/A	Flare Type RT	
N/A	Landing Length (in)	N/A			N/A
N/A	Landing Width (in)	N/A	N/A	Flare Slope RT (%)	N/A
N/A	Landing Run Slope (%)	N/A	N/A	Flare Traversable RT	N/A
N/A	Landing Cross Slope (%)	N/A	N/A	DWS Provided	N/A
N/A	Landing Movement Obstructed?	N/A	N/A	DWS Contrast	N/A
	Landing Movement Type	N/A	N/A	DWS Length (in)	N/A
N/A	Landing Shared	N/A	N/A	DWS Full Width	N/A
N/A	Clear Space	Yes	N/A	DWS Offset Left (in)	N/A
N/A	Clear Space To Crosswalk (in)	48	N/A	DWS Offset Right (in)	N/A
N/A	Marked Crosswalk 1	Yes	N/A	Marked Crosswalk 2	Yes
	Crossing 1 Direction	S		Crossing 2 Direction	E
	Marked Crosswalk 1 Width (in)	120		Marked Crosswalk 2 Width (in)	120

N/A	Ramp Inside Crosswalk 1	Yes	Yes	Ramp Inside Crosswalk 2	Yes
	Crossing 1 Slope (%)	0.6		Crossing 2 Slope (%)	2.6
	Crossing 1 Cross Slope (%)	2		Crossing 2 Cross Slope (%)	1.2
N/A	Gutter Ponding	N/A	No	Curb Slope	5.3
Yes	Gutter Lip Height (in)	0		Road Run Slope (%)	0.4
N/A	Gutter Run Slope (%)	N/A		Road Cross Slope (%)	2.2
N/A	Gutter Cross Slope (%)	N/A			
Yes	Overall Surface Condition: Acceptable		Yes	Perp Joint Present	Yes
	Cross Gutter Present?	Yes		Spandrel Present?	Yes
	Replace Cross Gutter?	No		Replace Spandrel?	No

Possible Solutions:
Remove & Replace Curb Ramp With Two New Directional Ramps or Equivalent.

OC Std/PROW:
R304.2.2, STD 1115
