# Access Compliance Report Public Rights-of-Way (Curb Ramps)

Main Street: E\_BLUE\_BIRD\_RD Cross Street: HEWES\_ST Location: SE

ADA ID: RPAT211027144147 Ramp Type: Type 1 - Perpendicular Diagonal Initial Pass/Fail: Fail Overall Compliance: No Severity Score: 2

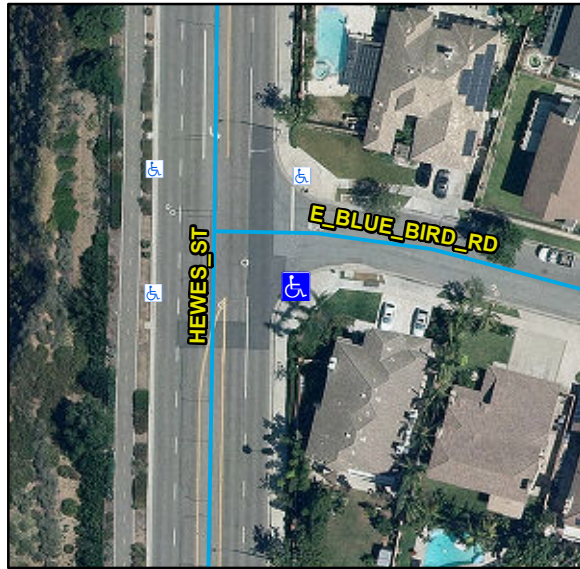
| Compliance | Description | Data | Compliance | Description | Data |
|---|---|---|---|---|---|
| No | Ramp Cross Slope (%) | 4.6 | N/A | Flare Traversable LT | N/A |

Remove & Replace Curb Ramp With Two New Directional Ramps or Equivalent.

R204.3, R304.5.3, STD 1115

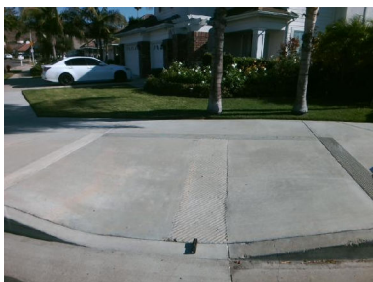
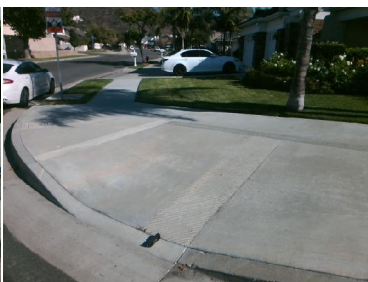
| Compliance | Description | Data | Compliance | Description | Data |
|---|---|---|---|---|---|
| Yes | Overall Surface Condition: Acceptable | | No | Perp Joint Present | No |
