# Access Compliance Report Public Rights-of-Way (Curb Ramps)

Main Street: HEWES\_ST Cross Street: E\_BLUE\_BIRD\_RD Location: NE

ADA ID: RPAT211027144442 Ramp Type: Type 1 - Perpendicular Diagonal Initial Pass/Fail: Fail Overall Compliance: No Severity Score: 2

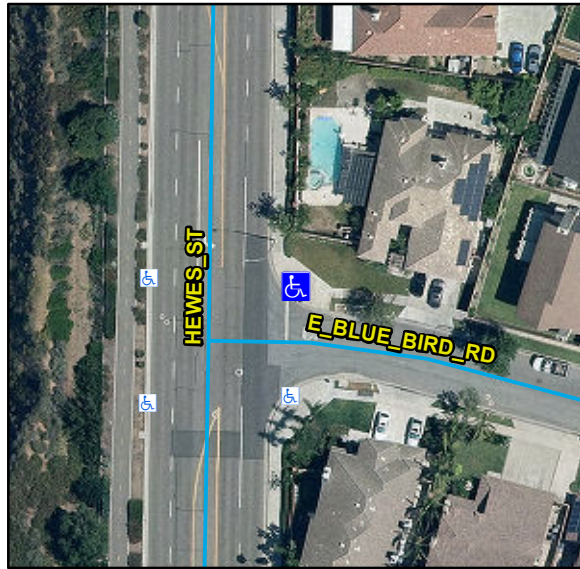
| Compliance | Description | Data | Compliance | Description | Data |
|---|---|---|---|---|---|
| No | Ramp Cross Slope (%) | 3.3 | N/A | Flare Traversable LT | N/A |

Remove & Replace Curb Ramp With Two New Directional Ramps or Equivalent.

R204.3, R304.5.3, STD 1115
