# Access Compliance Report Public Rights-of-Way (Curb Ramps)

Main Street: BOND\_AVE Cross Street: LITTLE\_LN Location: SE

ADA ID: RPAT211027145135 Ramp Type: Type 1 - Perpendicular Diagonal Initial Pass/Fail: Pass Overall Compliance: No Severity Score: 11

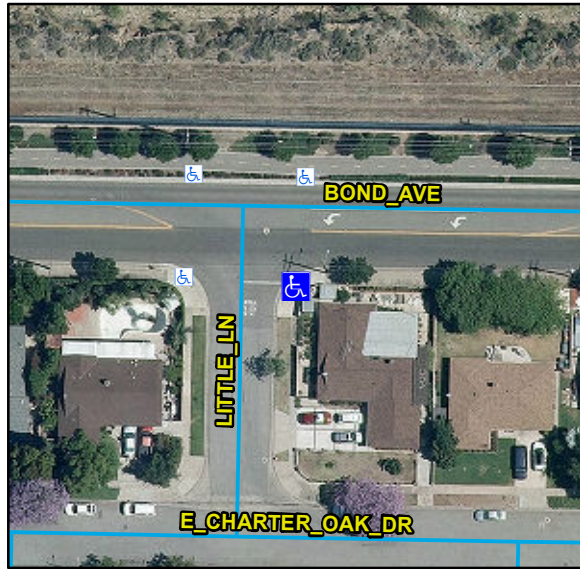
| Compliance | Description | Data | Compliance | Description | Data |
|---|---|---|---|---|---|
| Yes | Gutter Ponding | No | No | Curb Slope | 8 |
| No | Gutter Run Slope (%) | 7 | | Road Cross Slope (%) | 5.2 |

Remove & Replace Curb Ramp With Two New Directional Ramps or Equivalent. Remove & Replace Gutter.

R304.2.2, R304.2.1, R304.5.4, STD 1115
