# Access Compliance Report Public Rights-of-Way (Curb Ramps)

Main Street: LITTLE\_LN Cross Street: BOND\_AVE Location: SW

ADA ID: RPAT211027145521 Ramp Type: Type 1 - Perpendicular Diagonal Initial Pass/Fail: Fail Overall Compliance: No Severity Score: 15

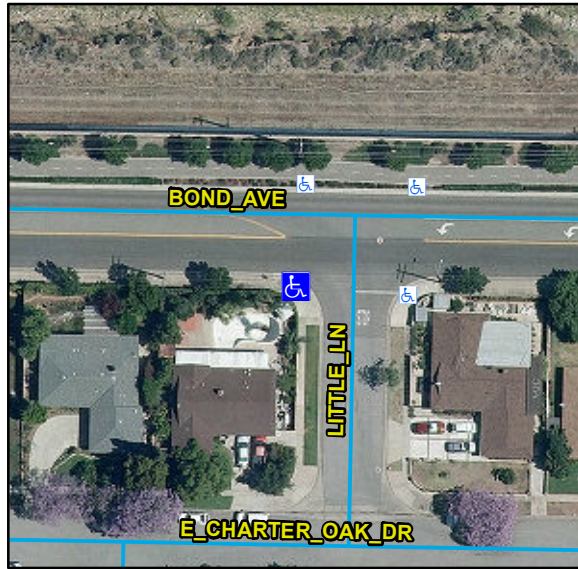
| Compliance | Description | Data | Compliance | Description | Data |
|---|---|---|---|---|---|
| No | Ramp Run Slope (%) | 8.4 | N/A | Flare Slope LT (%) | N/A |

**Remove & Replace Curb Ramp With Two New Directional Ramps or Equivalent.**

**R304.2.2, STD 1115**
