# Access Compliance Report Public Rights-of-Way (Curb Ramps)

Main Street: BOND\_AVE Cross Street: N\_RICK\_ST Location: SE

ADA ID: RPAT211027150504 Ramp Type: Type 1 - Perpendicular Diagonal Initial Pass/Fail: Pass Overall Compliance: No Severity Score: 6

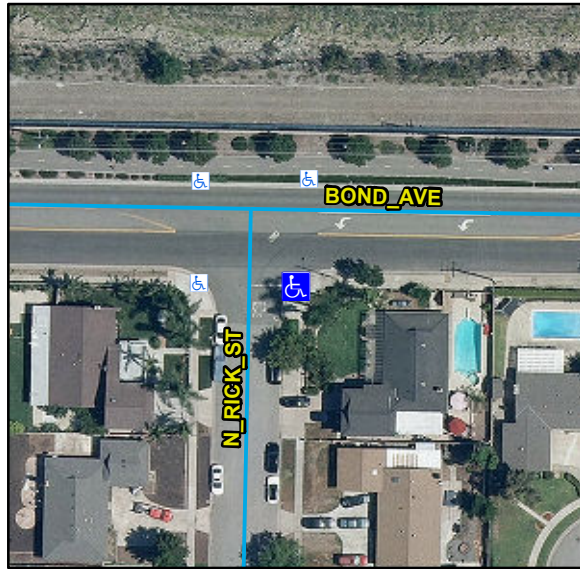
| Compliance | Description | Data | Compliance | Description | Data |
|---|---|---|---|---|---|
| No | Gutter Cross Slope (%) | 2.9 | | | |

Remove & Replace Landing. Remove & Replace Gutter.

R304.2.1, R304.5.3, STD 1115
