# Access Compliance Report Public Rights-of-Way (Curb Ramps)

Main Street: BOND\_AVE Cross Street: PROSPECT\_ST Location: S

ADA ID: RPAT211028082946 Ramp Type: Type 1 - Perpendicular Diagonal Initial Pass/Fail: Fail Overall Compliance: No Severity Score: 5

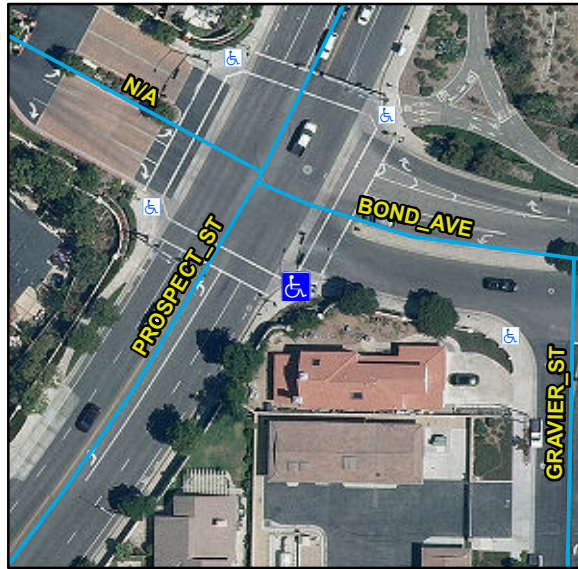
| Compliance | Description | Data | Compliance | Description | Data |
|---|---|---|---|---|---|
| No | Ramp Width (in) | 47 | | | N/A |
| No | Ramp Cross Slope (%) | 2.4 | N/A | Flare Traversable LT | N/A |

Remove & Replace Curb Ramp With Two New Directional Ramps or Equivalent.

R304.5.1, R304.5.3, STD 1115
