# Access Compliance Report Public Rights-of-Way (Curb Ramps)

Main Street: PROSPECT\_ST Cross Street: N/A Location: W

ADA ID: RPAT211028083753 Ramp Type: Type 1 - Perpendicular Diagonal Initial Pass/Fail: Fail Overall Compliance: No Severity Score: 4

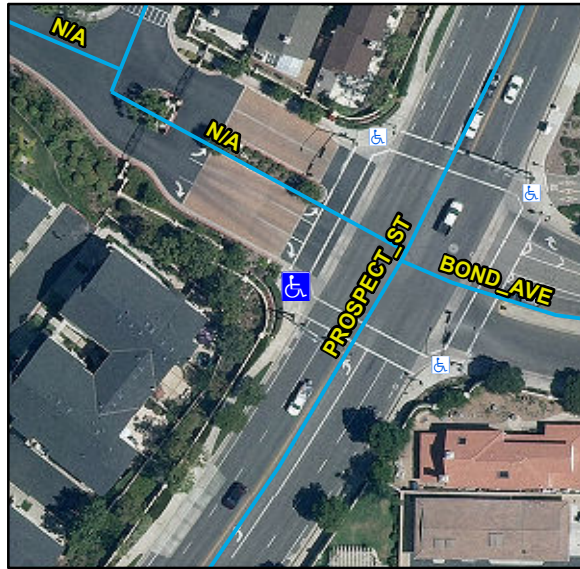
| Compliance | Description | Data | Compliance | Description | Data |
|---|---|---|---|---|---|
| No | Ramp Width (in) | 47 | | | N/A |
| N/A | Gutter Ponding | N/A | No | Curb Slope | 12.6 |

Remove & Replace Curb Ramp With Two New Directional Ramps or Equivalent.

R304.2.2, R304.5.1, STD 1115
