# Access Compliance Report Public Rights-of-Way (Curb Ramps)

Main Street: N/A Cross Street: PROSPECT\_ST Location: NW

ADA ID: RPAT211028084344 Ramp Type: Type 1 - Perpendicular Diagonal Initial Pass/Fail: Fail Overall Compliance: No Severity Score: 5

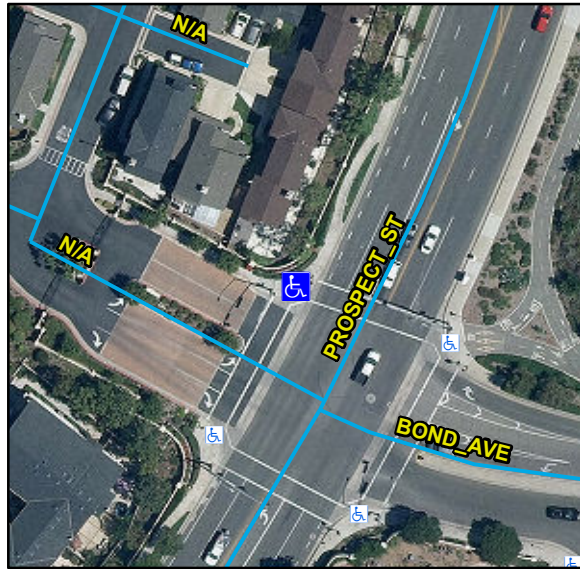
| Compliance | Description | Data | Compliance | Description | Data |
|---|---|---|---|---|---|
| No | Ramp Width (in) | 47 | | | N/A |
| N/A | Gutter Ponding | N/A | No | Curb Slope | 14.9 |

Remove & Replace Curb Ramp With Two New Directional Ramps or Equivalent.

R304.2.2, R304.5.1, STD 1115
