# Access Compliance Report Public Rights-of-Way (Curb Ramps)

Main Street: PROSPECT\_ST Cross Street: BOND\_AVE Location: E

ADA ID: RPAT211028084927 Ramp Type: Type 1 - Perpendicular Diagonal Initial Pass/Fail: Fail Overall Compliance: No Severity Score: 19

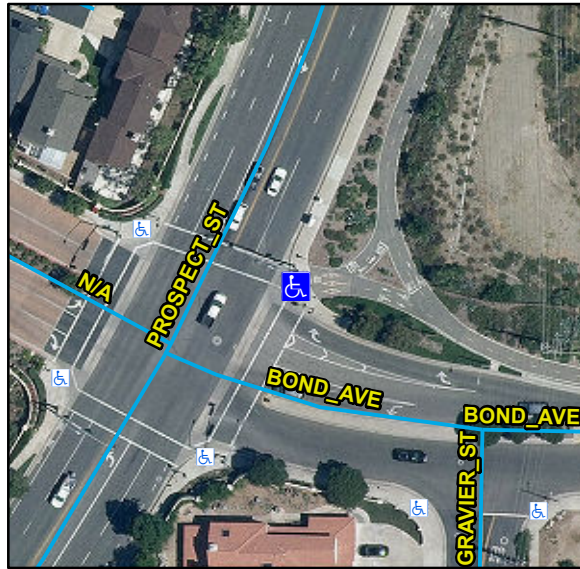
| Compliance | Description | Data | Compliance | Description | Data |
|---|---|---|---|---|---|
| N/A | Ramp Length (in) | 63 | N/A | Flare Type LT | |
| No | Ramp Width (in) | 46 | | | N/A |
| No | Ramp Run Slope (%) | 9.3 | N/A | Flare Slope LT (%) | N/A |

Remove & Replace Curb Ramp With Two New Directional Ramps or Equivalent.

R304.5.1, R304.2.2, STD 1115
