# Access Compliance Report Public Rights-of-Way (Curb Ramps)

Main Street: CANDLEWIND\_CT Cross Street: CELESTINE\_CIR Location: NE

ADA ID: RPAT211029120554 Ramp Type: Type 4 - Parallel Initial Pass/Fail: Pass Overall Compliance: No Severity Score: 15

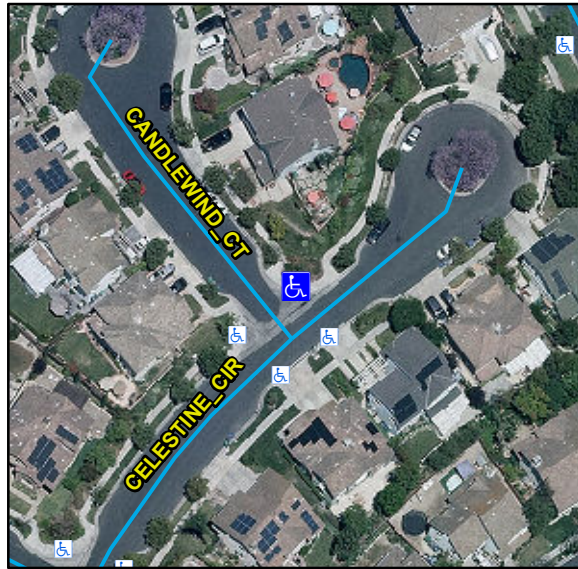
| Compliance | Description | Data | Compliance | Description | Data |
|---|---|---|---|---|---|
| N/A | Landing Present | Yes | No | DWS Provided | No |
| Yes | Gutter Ponding | No | No | Curb Slope | 10 |
| No | Gutter Run Slope (%) | 7.4 | | Road Cross Slope (%) | 3.3 |
| Yes | Gutter Cross Slope (%) | 1.3 | No | Perpendicular Joint Present | No |

**Remove & Replace Curb Ramp With Two New Directional Ramps or Equivalent. Remove & Replace Gutter.**
