# Access Compliance Report Public Rights-of-Way (Curb Ramps)

Main Street: CELESTINE\_CIR Cross Street: CANDLEWIND\_CT Location: NW

ADA ID: RPAT211029121026 Ramp Type: Type 4 - Parallel Initial Pass/Fail: Fail Overall Compliance: No Severity Score: 2

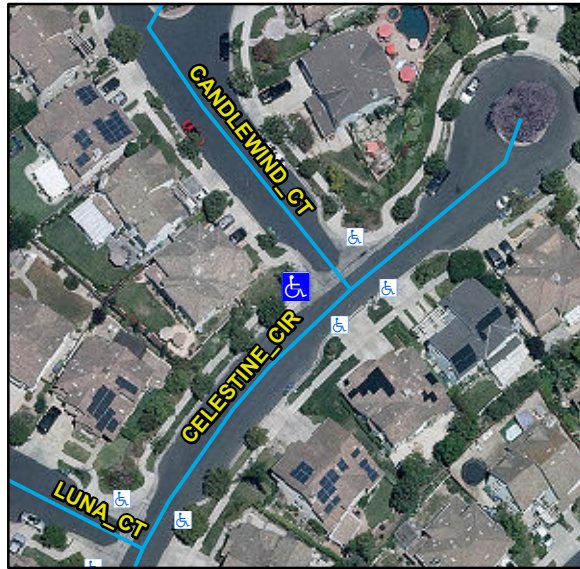
| Compliance | Description | Data | Compliance | Description | Data |
|---|---|---|---|---|---|
| No | Ramp Cross Slope LT (%) | 2.3 | Yes | Ramp Cross Slope RT (%) | 1.5 |

Remove & Replace Curb Ramp With Two New Directional Ramps or Equivalent.
