# Access Compliance Report Public Rights-of-Way (Curb Ramps)

Main Street: LUNA\_CT Cross Street: CELESTINE\_CIR Location: NE

ADA ID: RPAT211029121409 Ramp Type: Type 4 - Parallel Initial Pass/Fail: Pass Overall Compliance: No Severity Score: 16

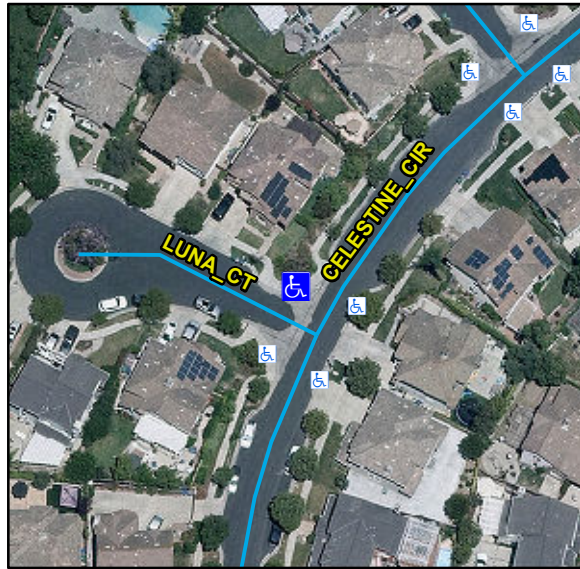
| Compliance | Description | Data | Compliance | Description | Data |
|---|---|---|---|---|---|
| No | Ramp Cross Slope LT (%) | 2.3 | Yes | Ramp Cross Slope RT (%) | 0.8 |
| N/A | Landing Present | Yes | No | DWS Provided | No |
| No | Gutter Run Slope (%) | 6.8 | | Road Cross Slope (%) | 2 |

**Remove & Replace Curb Ramp With Two New Directional Ramps or Equivalent. Remove & Replace Gutter.**
