# Access Compliance Report Public Rights-of-Way (Curb Ramps)

Main Street: CELESTINE\_CIR Cross Street: LUNA\_CT Location: W

ADA ID: RPAT211029121835 Ramp Type: Type 4 - Parallel Initial Pass/Fail: Pass Overall Compliance: No Severity Score: 10

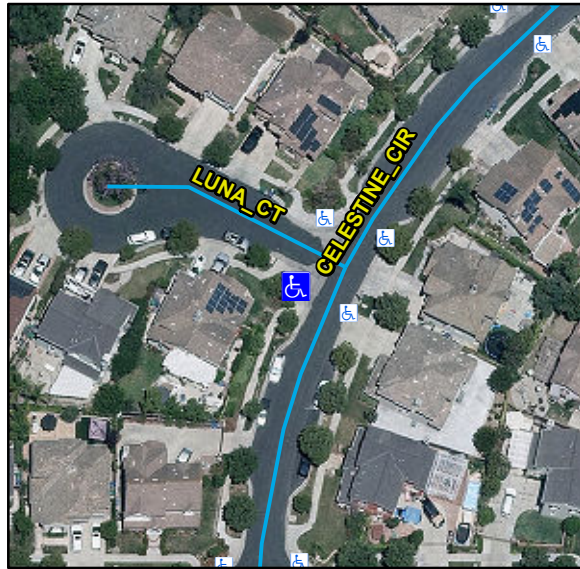
| Compliance | Description | Data | Compliance | Description | Data |
|---|---|---|---|---|---|
| N/A | Landing Present | Yes | No | DWS Provided | No |
| Yes | Gutter Ponding | No | No | Curb Slope | 10.1 |
| Yes | Gutter Cross Slope (%) | 0.3 | No | Perpendicular Joint Present | No |

Remove & Replace Curb Ramp With Two New Directional Ramps or Equivalent.
