# Access Compliance Report Public Rights-of-Way (Curb Ramps)

Main Street: MERRIWEATHER\_PL Cross Street: CELESTINE\_CIR Location: NW

ADA ID: RPAT211029122310 Ramp Type: Type 4 - Parallel Initial Pass/Fail: Fail Overall Compliance: No Severity Score: 15

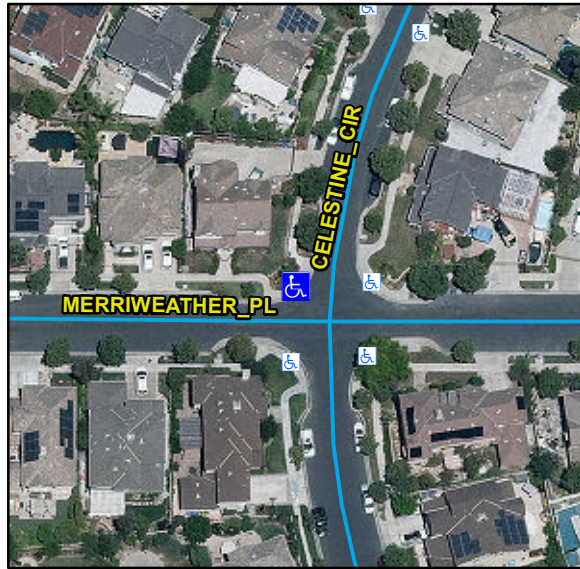
| Compliance | Description | Data | Compliance | Description | Data |
|---|---|---|---|---|---|
| No | Ramp Run Slope LT (%) | 8.9 | Yes | Ramp Run Slope RT (%) | 8.2 |

**Remove & Replace Curb Ramp With Two New Directional Ramps or Equivalent.**
