# Access Compliance Report Public Rights-of-Way (Curb Ramps)

Main Street: CELESTINE\_CIR Cross Street: MERRIWEATHER\_PL Location: SW

ADA ID: RPAT211029122526 Ramp Type: Type 4 - Parallel Initial Pass/Fail: Fail Overall Compliance: No Severity Score: 15

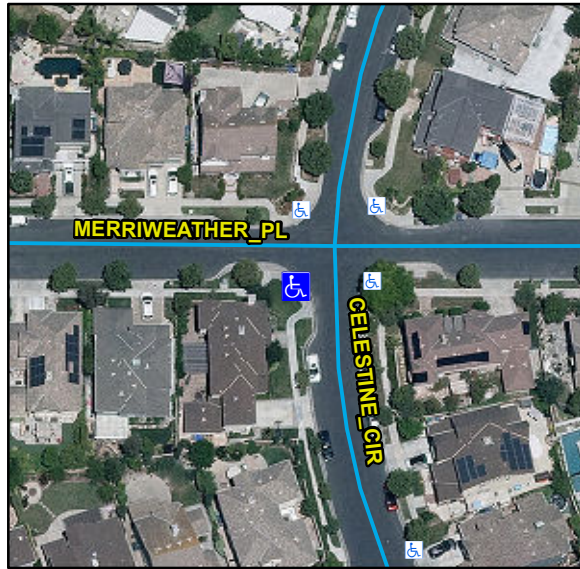
| Compliance | Description | Data | Compliance | Description | Data |
|---|---|---|---|---|---|
| No | Ramp Run Slope LT (%) | 8.4 | Yes | Ramp Run Slope RT (%) | 6.7 |

**Remove & Replace Curb Ramp With Two New Directional Ramps or Equivalent.**

**R204.3, R304.3.2, STD 1115**
