# Access Compliance Report Public Rights-of-Way (Curb Ramps)

| Main Street: CELESTINE_CIR | | Cross Street: PLUM_ST | | Location: | SW |
| ADA ID: RPAT211029123158 | Ramp Type: Type 4 - Parallel | Initial Pass/Fail: Fail | Overall Compliance: No | Severity Score: | 2 |

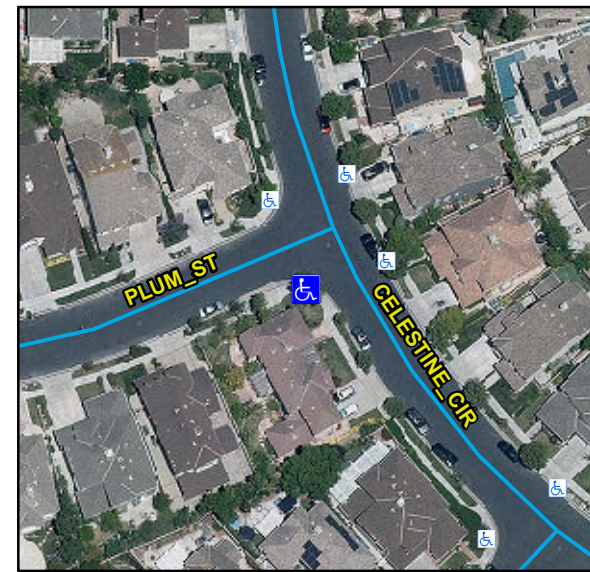
| Compliance | Description | Data | Compliance | Description | Data |
|---|---|---|---|---|---|
| No | Ramp Cross Slope LT (%) | 3.1 | Yes | Ramp Cross Slope RT (%) | 1.1 |

**Remove & Replace Curb Ramp With Two New Directional Ramps or Equivalent.**

**R204.3, R304.5.3, STD 1115**

Total Cost: \$ 4000
