# Access Compliance Report Public Rights-of-Way (Curb Ramps)

Main Street: OLIVE\_ST Cross Street: CELESTINE\_CIR Location: NW

ADA ID: RPAT211029123528 Ramp Type: Type 4 - Parallel Initial Pass/Fail: Pass Overall Compliance: No Severity Score: 16

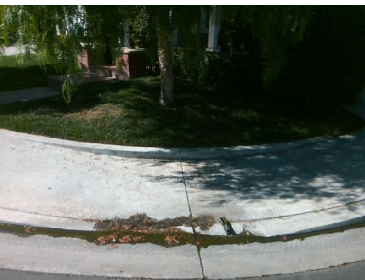
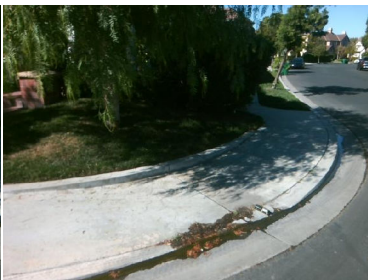
| Compliance | Description | Data | Compliance | Description | Data |
|---|---|---|---|---|---|
| Yes | Ramp Cross Slope LT (%) | 1 | No | Ramp Cross Slope RT (%) | 2.1 |
| N/A | Landing Present | Yes | No | DWS Provided | No |
| No | Gutter Ponding | Yes | N/A | Curb Slope | 7.2 |
| No | Gutter Run Slope (%) | 7.3 | | Road Cross Slope (%) | 0.8 |
| Yes | Gutter Cross Slope (%) | 0.6 | No | Perpendicular Joint Present | No |

Remove & Replace Curb Ramp With Two New Directional Ramps or Equivalent. Remove & Replace Gutter.
