# Access Compliance Report Public Rights-of-Way (Curb Ramps)

Main Street: CELESTINE\_CIR Cross Street: OLIVE\_ST Location: SW

ADA ID: RPAT211029123914 Ramp Type: Type 4 - Parallel Initial Pass/Fail: Fail Overall Compliance: No Severity Score: 16

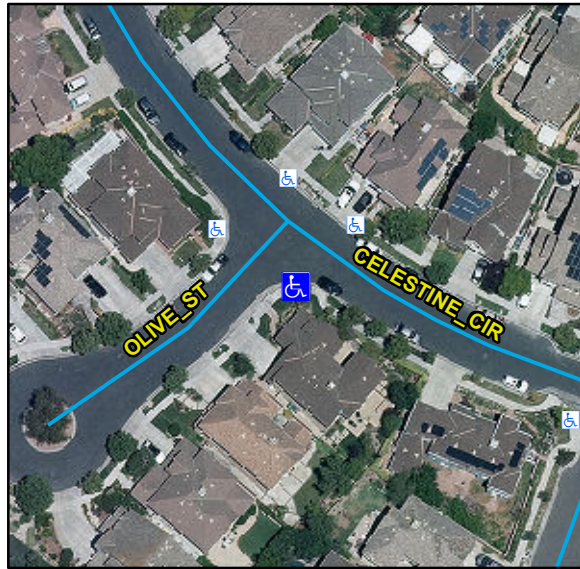
| Compliance | Description | Data | Compliance | Description | Data |
|---|---|---|---|---|---|
| No | Ramp Run Slope LT (%) | 8.7 | Yes | Ramp Run Slope RT (%) | 5.2 |
| No | Ramp Cross Slope LT (%) | 2.9 | No | Ramp Cross Slope RT (%) | 3.7 |

**Remove & Replace Curb Ramp With Two New Directional Ramps or Equivalent.**
