# Access Compliance Report Public Rights-of-Way (Curb Ramps)

Main Street: BEECHTREE\_ST Cross Street: CELESTINE\_CIR Location: W

ADA ID: RPAT211029124345 Ramp Type: Type 4 - Parallel Initial Pass/Fail: Pass Overall Compliance: No Severity Score: 16

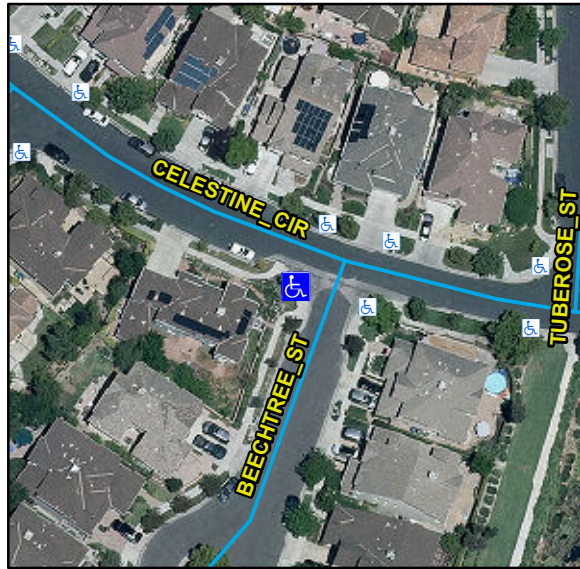
| Compliance | Description | Data | Compliance | Description | Data |
|---|---|---|---|---|---|
| N/A | Landing Present | Yes | No | DWS Provided | No |
| No | Landing Cross Slope (%) | 2.4 | | DWS Offset Type | N/A |
| Yes | Gutter Ponding | No | No | Curb Slope | 9.2 |
| No | Gutter Run Slope (%) | 5.8 | | Road Cross Slope (%) | 0.8 |
| No | Gutter Cross Slope (%) | 2.5 | No | Perpendicular Joint Present | No |

Remove & Replace Curb Ramp With Two New Directional Ramps or Equivalent. Remove & Replace Gutter.

R304.2.2, R204.3, R304.5.3, R305, R304.5.4, STD 1115
