# Access Compliance Report Public Rights-of-Way (Curb Ramps)

Main Street: CELESTINE\_CIR Cross Street: BEECHTREE\_ST Location: S

ADA ID: RPAT211029124745 Ramp Type: Type 4 - Parallel Initial Pass/Fail: Fail Overall Compliance: No Severity Score: 15

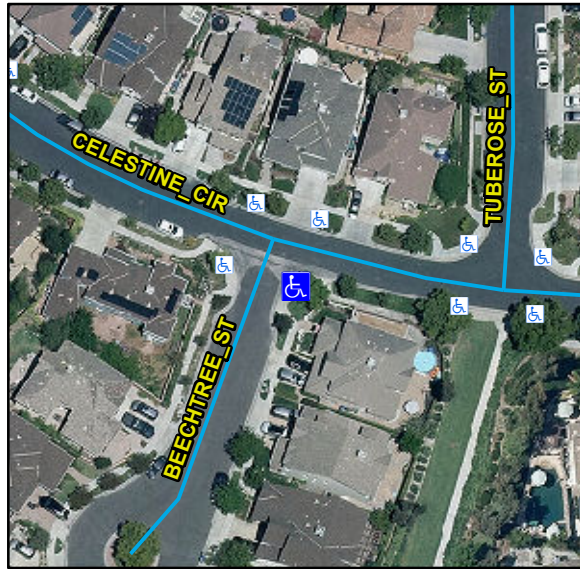
| Compliance | Description | Data | Compliance | Description | Data |
|---|---|---|---|---|---|
| Yes | Ramp Run Slope LT (%) | 4.7 | Yes | Ramp Run Slope RT (%) | 3.8 |
| No | Ramp Cross Slope LT (%) | 2.8 | No | Ramp Cross Slope RT (%) | 5.5 |

Remove & Replace Curb Ramp With Two New Directional Ramps or Equivalent.

R204.3, R304.5.3, STD 1115
