# Access Compliance Report Public Rights-of-Way (Curb Ramps)

Main Street: CELESTINE\_CIR Cross Street: TUBEROSE\_ST Location: SW

ADA ID: RPAT211029125235 Ramp Type: Type 4 - Parallel Initial Pass/Fail: Fail Overall Compliance: No Severity Score: 2

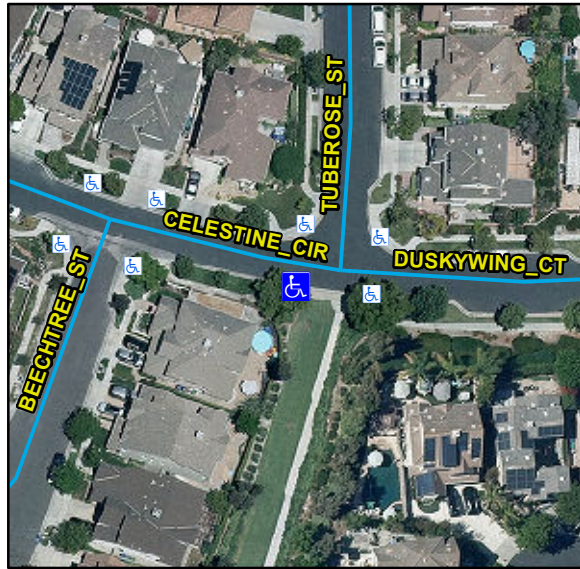
| Compliance | Description | Data | Compliance | Description | Data |
|---|---|---|---|---|---|
| Yes | Ramp Cross Slope LT (%) | 1 | No | Ramp Cross Slope RT (%) | 2.7 |
| N/A | Gutter Ponding | N/A | No | Curb Slope | 9.9 |
| N/A | Gutter Cross Slope (%) | N/A | No | Perpendicular Joint Present | No |

Remove & Replace Entire Ramp.

R304.2.2, R204.3, R304.5.3, STD 1115
