# Access Compliance Report Public Rights-of-Way (Curb Ramps)

Main Street: CELESTINE\_CIR Cross Street: TUBEROSE\_ST Location: NW

ADA ID: RPAT211029125502 Ramp Type: Type 4 - Parallel Initial Pass/Fail: Fail Overall Compliance: No Severity Score: 2

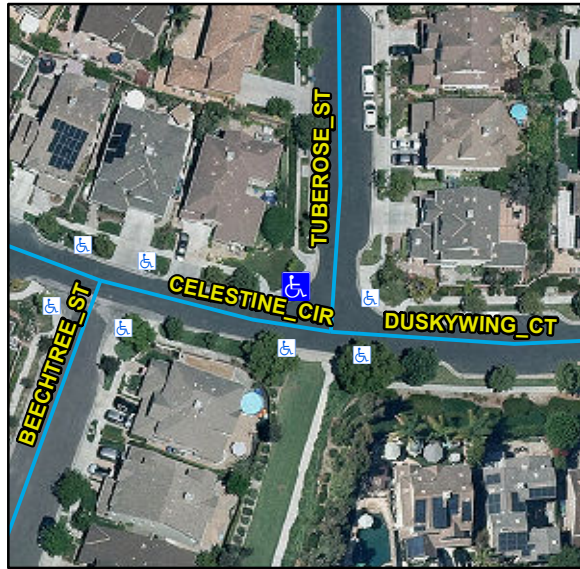
| Compliance | Description | Data | Compliance | Description | Data |
|---|---|---|---|---|---|
| No | Ramp Cross Slope LT (%) | 3.4 | Yes | Ramp Cross Slope RT (%) | 1.3 |

Remove & Replace Curb Ramp With Two New Directional Ramps or Equivalent.

R204.3, R304.5.3, STD 1115

Total Cost: \$ 4000
