# Access Compliance Report Public Rights-of-Way (Curb Ramps)

Main Street: TUBEROSE\_ST Cross Street: DUSKYWING\_CT Location: NE

ADA ID: RPAT211029125929 Ramp Type: Type 4 - Parallel Initial Pass/Fail: Fail Overall Compliance: No Severity Score: 16

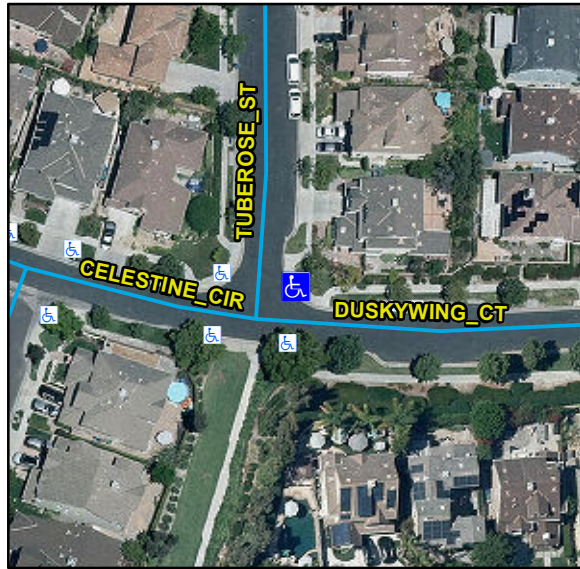
| Compliance | Description | Data | Compliance | Description | Data |
|---|---|---|---|---|---|
| Yes | Ramp Run Slope LT (%) | 0.3 | No | Ramp Run Slope RT (%) | 10.5 |
| Yes | Ramp Cross Slope LT (%) | 1.2 | No | Ramp Cross Slope RT (%) | 3.2 |

Remove & Replace Curb Ramp With Two New Directional Ramps or Equivalent.

R204.3, R304.3.2, R304.5.3, STD 1115
