# Access Compliance Report Public Rights-of-Way (Curb Ramps)

Main Street: DUSKYWING\_CT Cross Street: BLUEWING\_LN Location: NW

ADA ID: RPAT211029130307 Ramp Type: Type 4 - Parallel Initial Pass/Fail: Fail Overall Compliance: No Severity Score: 16

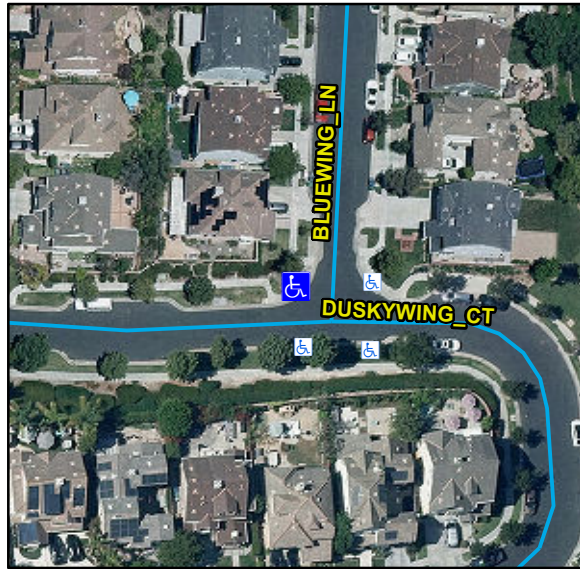
| Compliance | Description | Data | Compliance | Description | Data |
|---|---|---|---|---|---|
| Yes | Ramp Run Slope LT (%) | 1.7 | No | Ramp Run Slope RT (%) | 9.8 |
| No | Ramp Cross Slope LT (%) | 2.9 | No | Ramp Cross Slope RT (%) | 2.7 |

**Remove & Replace Curb Ramp With Two New Directional Ramps or Equivalent.**

**R204.3, R304.5.3, R304.3.2, STD 1115**

Total Cost: \$ 4000
