Access Compliance Report Public Rights-of-Way (Curb Ramps)

Main Street: BLUEWING_LN **Cross Street:** DUSKYWING_CT **Location:** NE

ADA ID: RPAT211029130548 **Ramp Type:** Type 4 - Parallel **Initial Pass/Fail:** Pass **Overall Compliance:** No **Severity Score:** 15

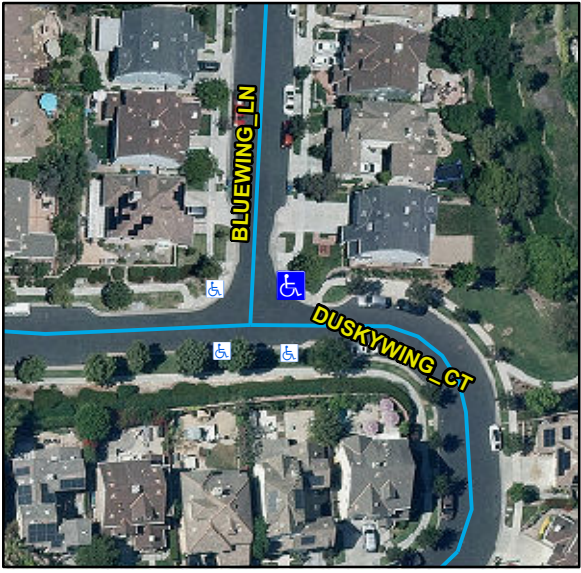
Compliance	Description	Data	Compliance	Description	Data
N/A	Ramp Length LT (in)	101	N/A	Ramp Length RT (in)	93
Yes	Ramp Width LT (in)	52	Yes	Ramp Width RT (in)	53
Yes	Ramp Run Slope LT (%)	4.1	Yes	Ramp Run Slope RT (%)	6.3
Yes	Ramp Cross Slope LT (%)	1.6	Yes	Ramp Cross Slope RT (%)	0.5
N/A	Landing Present	Yes	No	DWS Provided	No
N/A	Landing Length (in)	52	N/A	DWS Contrast	N/A
Yes	Landing Width (in)	58	N/A	DWS Length (in)	N/A
Yes	Landing Run Slope (%)	0.6	N/A	DWS Full Width	N/A
Yes	Landing Cross Slope (%)	1.4		DWS Offset Type	N/A
N/A	Landing Movement Obstructed?	No	N/A	DWS Offset Left (in)	N/A
	Landing Movement Type	Curb	N/A	DWS Offset Right (in)	N/A
N/A	Landing Shared	No			
N/A	Clear Space	Yes			
N/A	Clear Space To Crosswalk (in)	48			
N/A	Marked Crosswalk 1	No	N/A	Marked Crosswalk 2	No
	Crossing 1 Direction	W		Crossing 2 Direction	S
N/A	Marked Crosswalk 1 Width (in)	N/A	N/A	Marked Crosswalk 2 Width (in)	N/A

N/A	Ramp Inside Crosswalk 1	N/A	N/A	Ramp Inside Crosswalk 2	N/A
	Crossing 1 Slope (%)	1.7		Crossing 2 Slope (%)	0.4
	Crossing 1 Cross Slope (%)	1.1		Crossing 2 Cross Slope (%)	0.6
Yes	Gutter Ponding	No	No	Curb Slope	13.3
Yes	Gutter Lip Height (in)	0		Road Run Slope (%)	1
No	Gutter Run Slope (%)	10.8		Road Cross Slope (%)	0.5
Yes	Gutter Cross Slope (%)	0.5	No	Perpendicular Joint Present	No
Yes	Overall Surface Condition	Acceptable			
	Cross Gutter Present?	No		Spandrel Present?	No
	Replace Cross Gutter?	N/A		Replace Spandrel?	N/A

Possible Solutions:
Remove & Replace Curb Ramp With Two New Directional Ramps or Equivalent. Remove & Replace Gutter.

OC Std/PROW:
R304.2.2, R204.3, R305, R304.5.4, STD 1115
