# Access Compliance Report Public Rights-of-Way (Curb Ramps)

Main Street: TUBEROSE\_ST Cross Street: CLEOME\_ST Location: SW

ADA ID: RPAT211029131118 Ramp Type: Type 4 - Parallel Initial Pass/Fail: Pass Overall Compliance: No Severity Score: 20

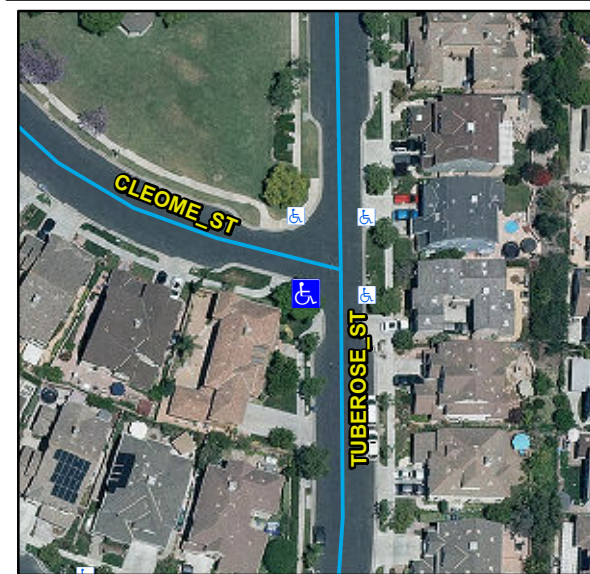
| Compliance | Description | Data | Compliance | Description | Data |
|---|---|---|---|---|---|
| N/A | Landing Present | Yes | No | DWS Provided | No |
| No | Landing Width (in) | 46 | N/A | DWS Length (in) | N/A |
| No | Landing Run Slope (%) | 2.9 | N/A | DWS Full Width | N/A |
| No | Gutter Ponding | Yes | No | Curb Slope | 9.4 |
| No | Gutter Run Slope (%) | 6.5 | | Road Cross Slope (%) | 0.3 |
| Yes | Gutter Cross Slope (%) | 1.2 | No | Perpendicular Joint Present | No |

Possible Solutions:  
**Remove & Replace Curb Ramp With Two New Directional Ramps or Equivalent. Remove & Replace Gutter.**

OC Std/PROW:  
**R304.2.2, R204.3, R304.2.1, R304.2.2-Perp, R304.3.2-Para, R305, R302.7, R304.5.4, STD 1115**
